**Closeout Report  
for IHSS Group 700-7**

**UBC 779, IHSS 700-138, IHSS 700-149.2,  
IHSS 700-150.6, IHSS 700-150.8,  
PAC 700-1105, and Portions of  
IHSS 000-101 and IHSS 000-121**

**September 2004**

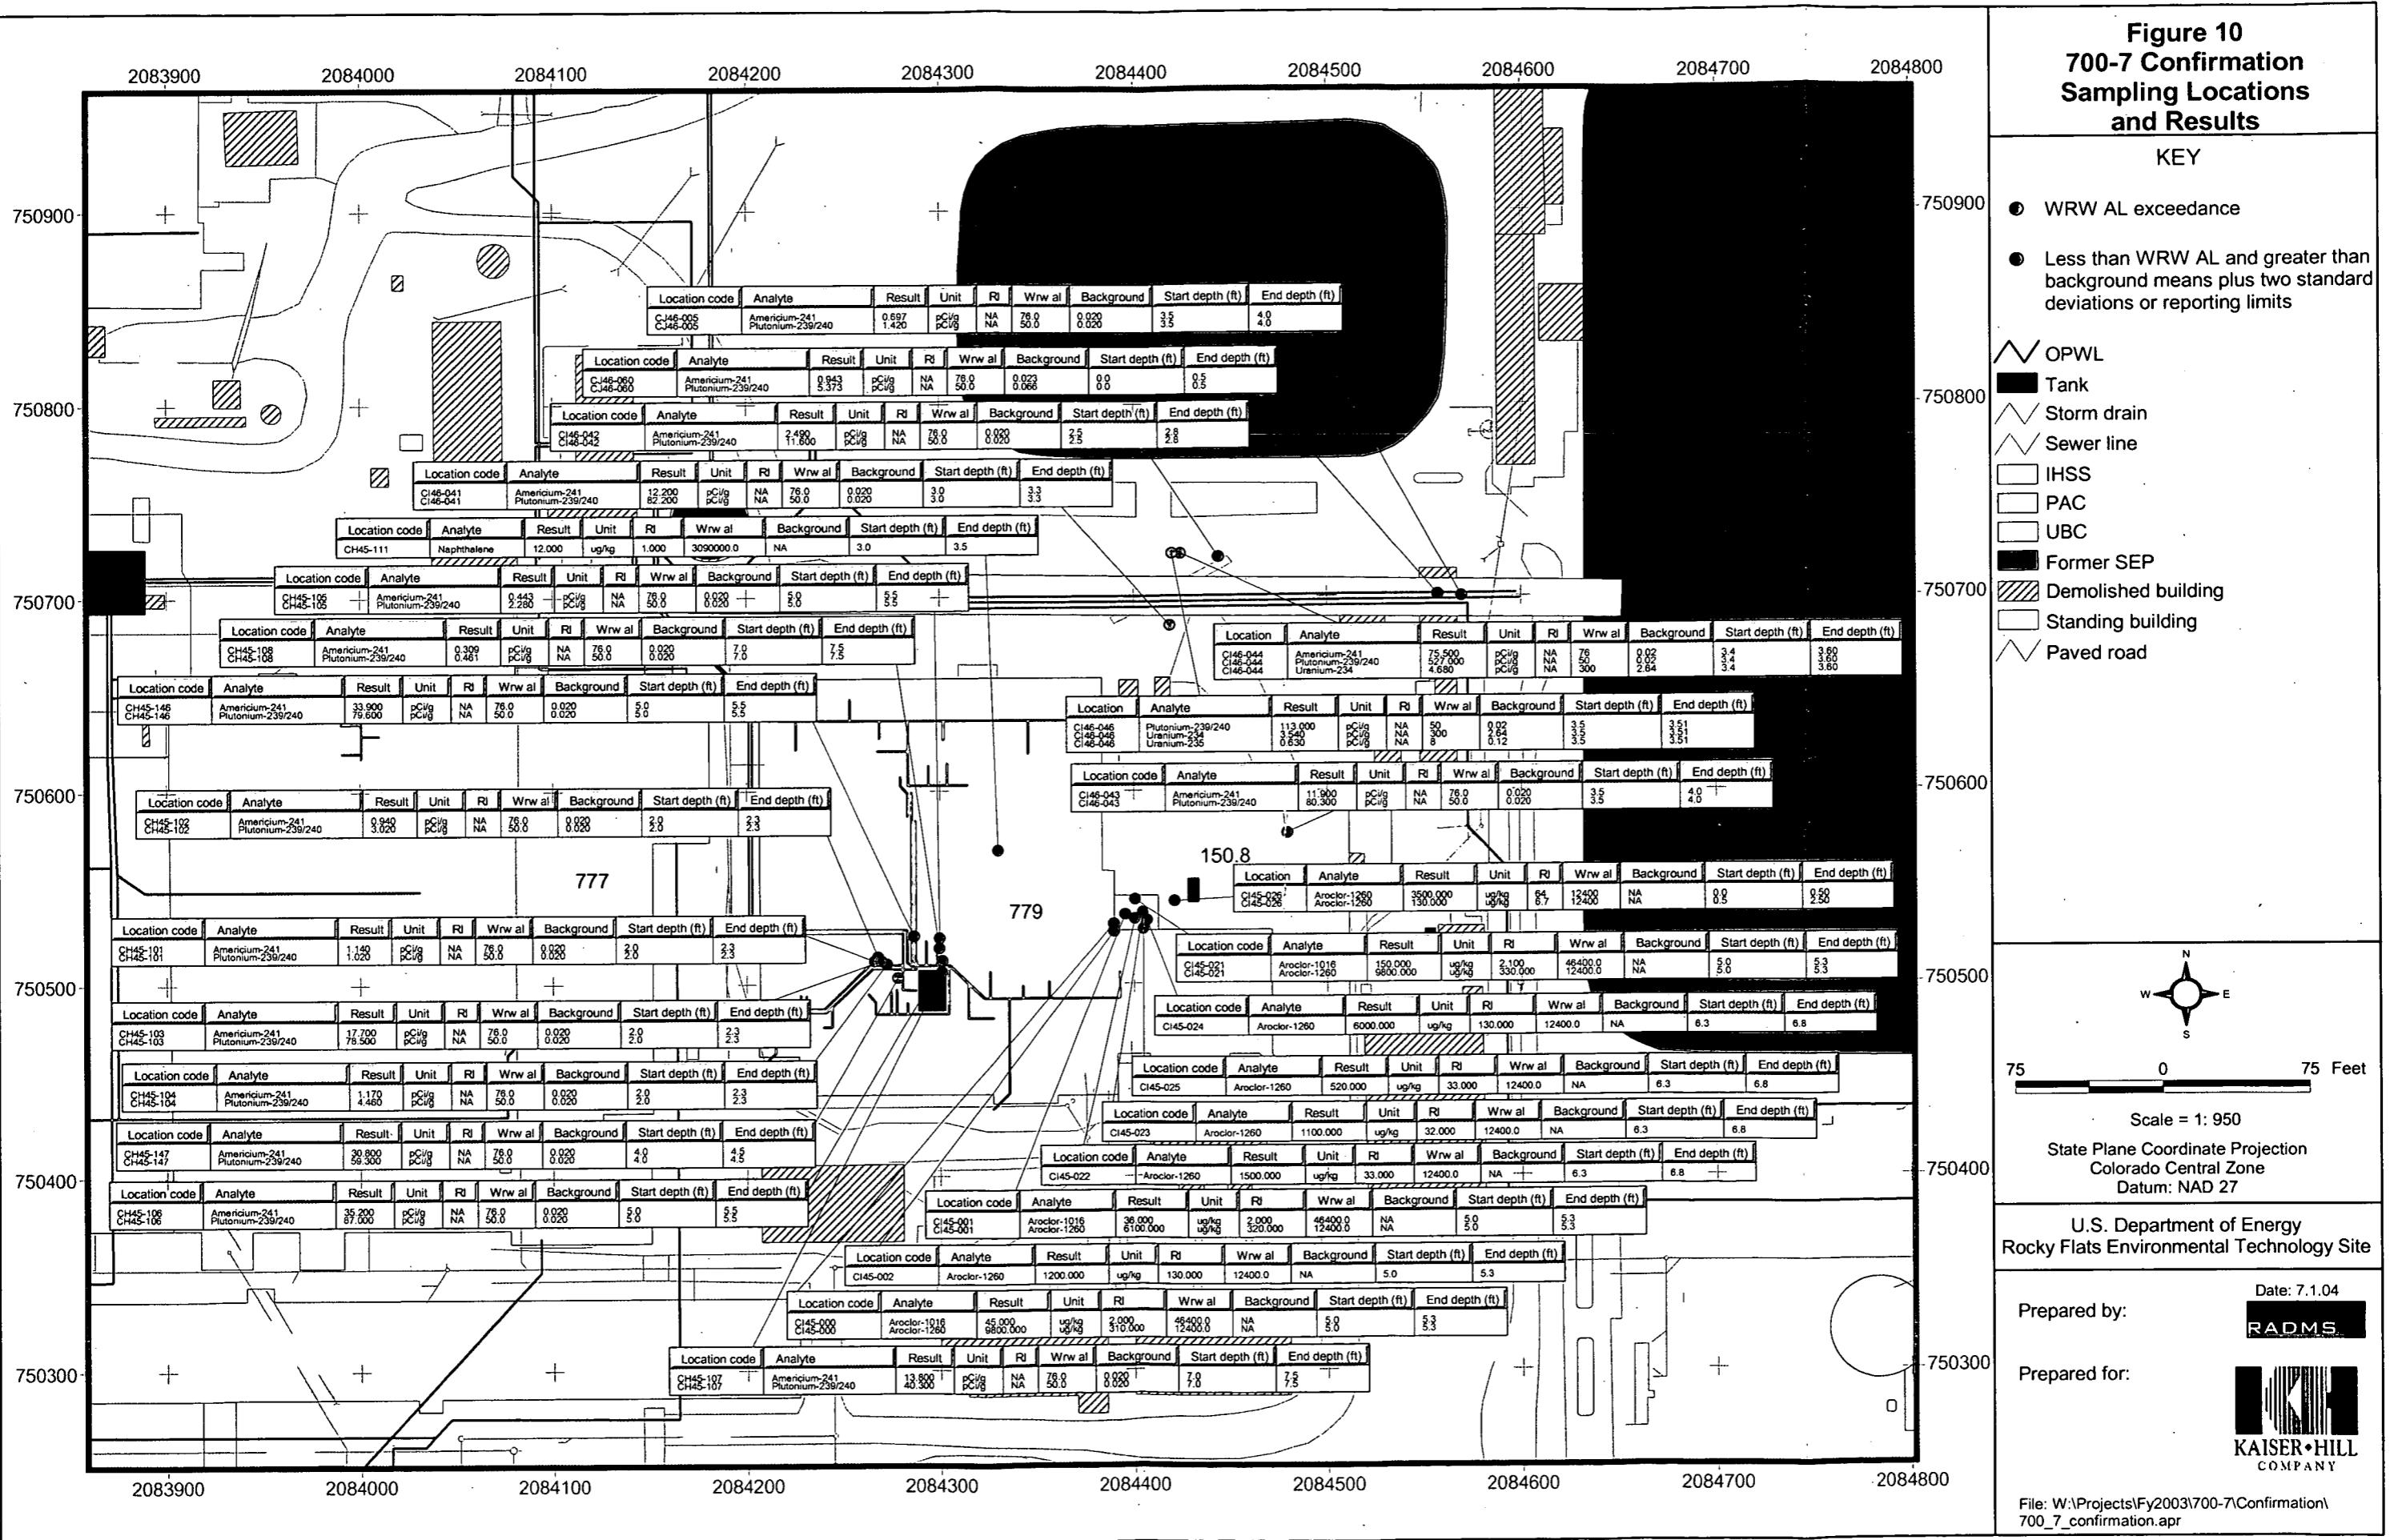
**Figure 10**  
**700-7 Confirmation**  
**Sampling Locations**  
**and Results**

- The Pu-239/240 activity at Sampling Location CI46-041 (within the area of the former Auxiliary Pond 2), at 3.0 to 3.3 feet, was 82.2 pCi/g, and the WRW AL is 50 pCi/g. However, the activity is less than 1 nCi/g at a depth greater than 3 feet from the ground surface, and based on RFCA and the SSRS (Section 6.0), additional removal is not required (RFCA Attachment 5, DOE et al. 2003).

- The Pu-239/240 activity at Sampling Location CI46-043 (within the area of the former Auxiliary Pond 2), at 3.5 to 4.0 feet, was 80.3 pCi/g, and the WRW AL is 50 pCi/g. However, the activity is less than 1 nCi/g at a depth greater than 3 feet from the ground surface, and based on RFCA and the SSRS (Section 6.0), additional removal is not required (RFCA Attachment 5, DOE et al. 2003).

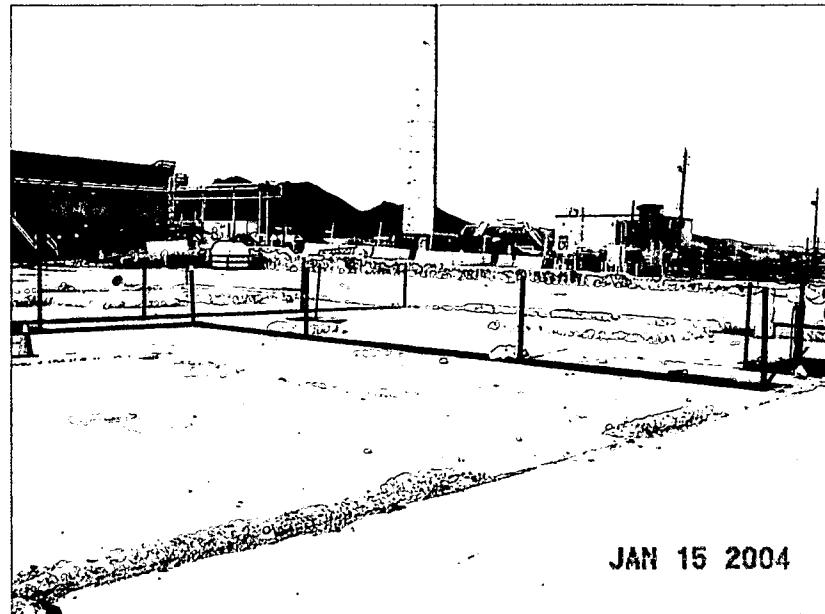
Building 779 Slab Before Removal

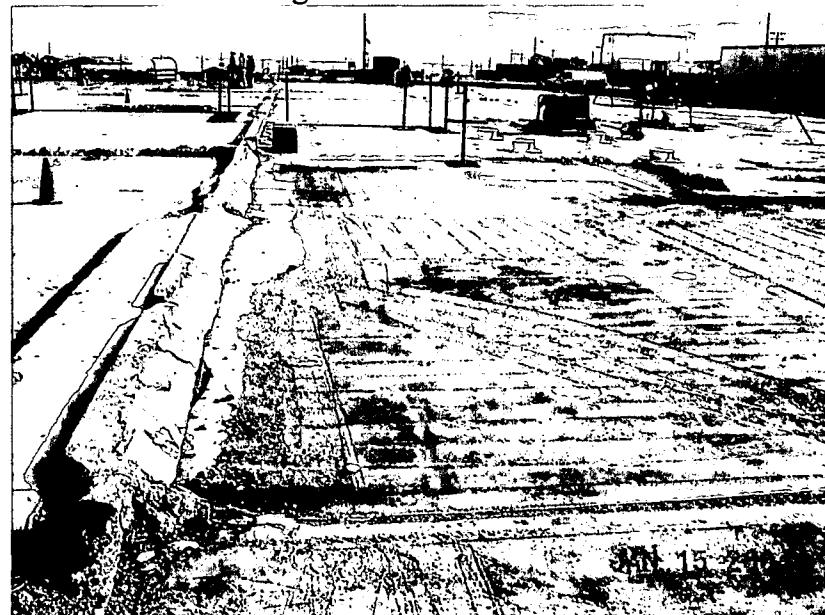
Scabbed Building 779 Slab Including Top of Basement

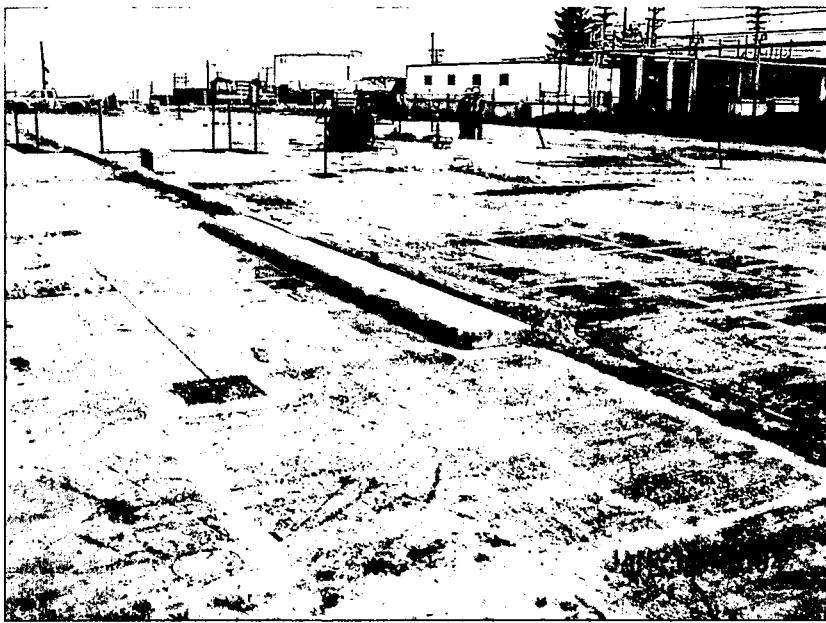
Scabbed Slab with Contamination Area 4' x 4' Sections Delineated

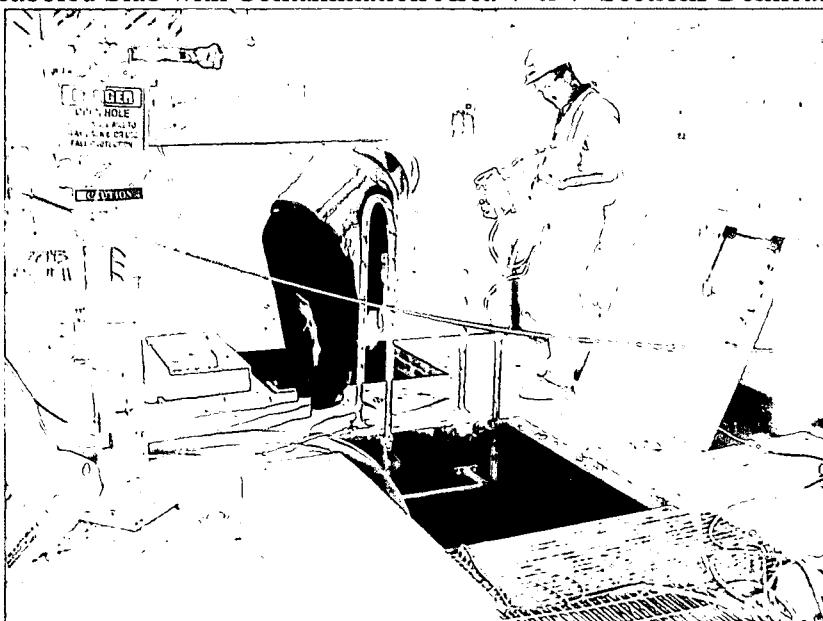
Building 779 Basement and Subbasement Tank Openings (T-2B & T-5)

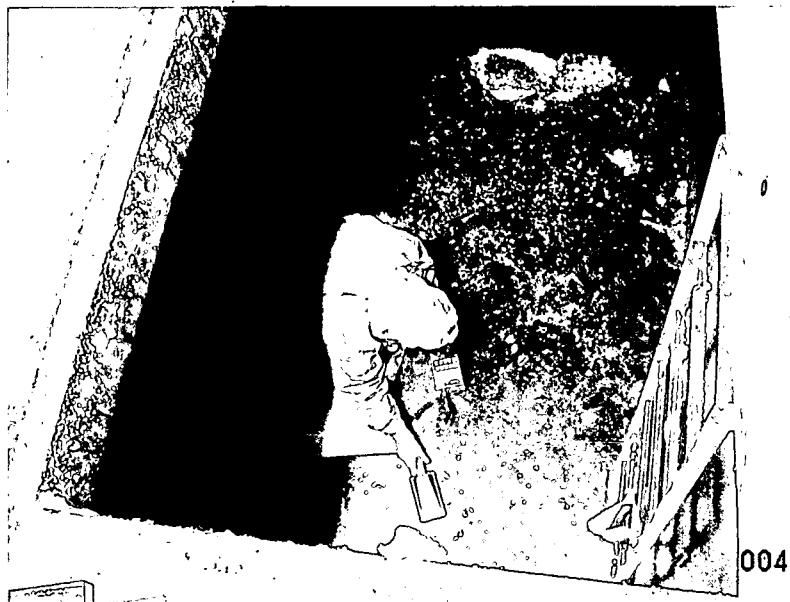
Surveying of a Building 779 Subbasement Tank

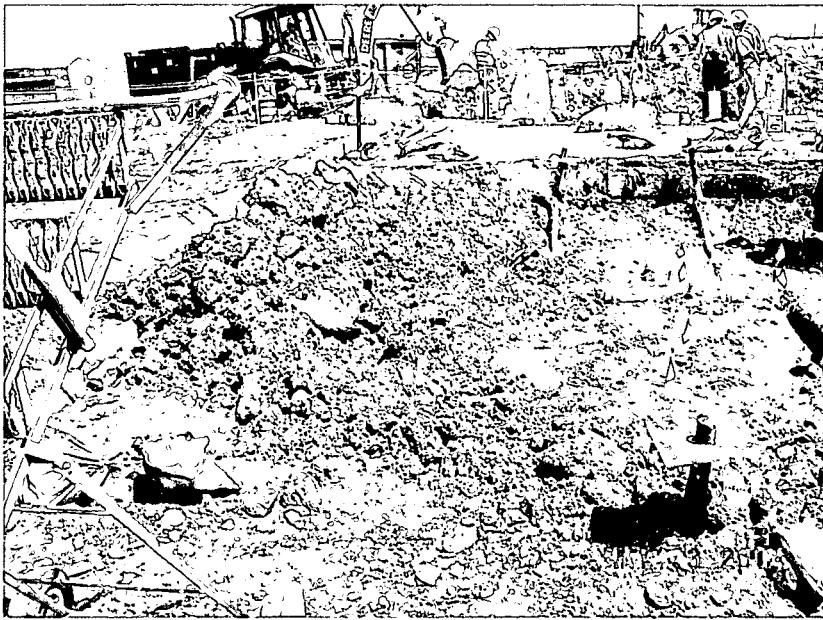
Contamination Area Excavation, Exposed Pipelines and Sampling Locations

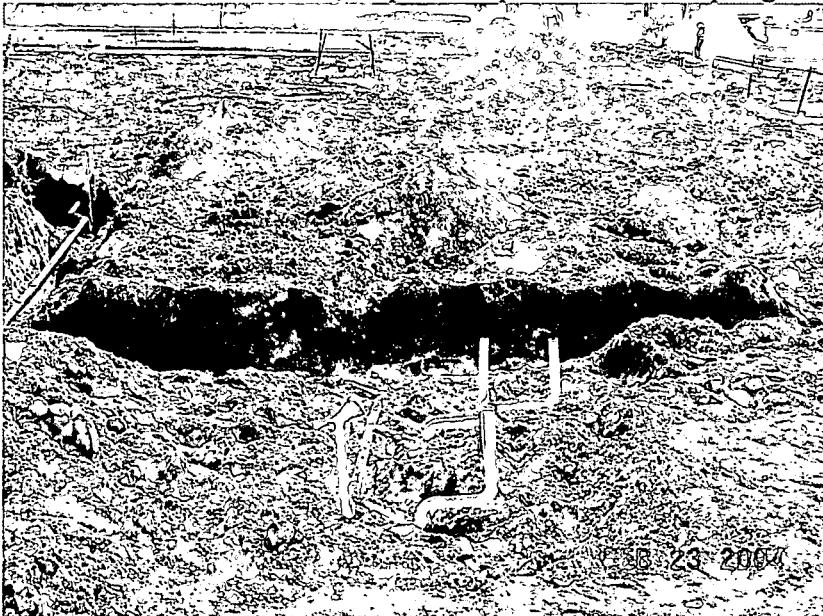
Building 779 OPWL Excavation

OPWL P-36, P-37, P-38 and P-42 are at least 4 feet below grade and will not be removed. The ends of the OPWL have been exposed, and were disrupted, drained and grouted under the IHSS Group 000- 2 project. One small section of P-36 near the Building 784 slab was damaged and was removed. Removed debris was disposed of as LLW.

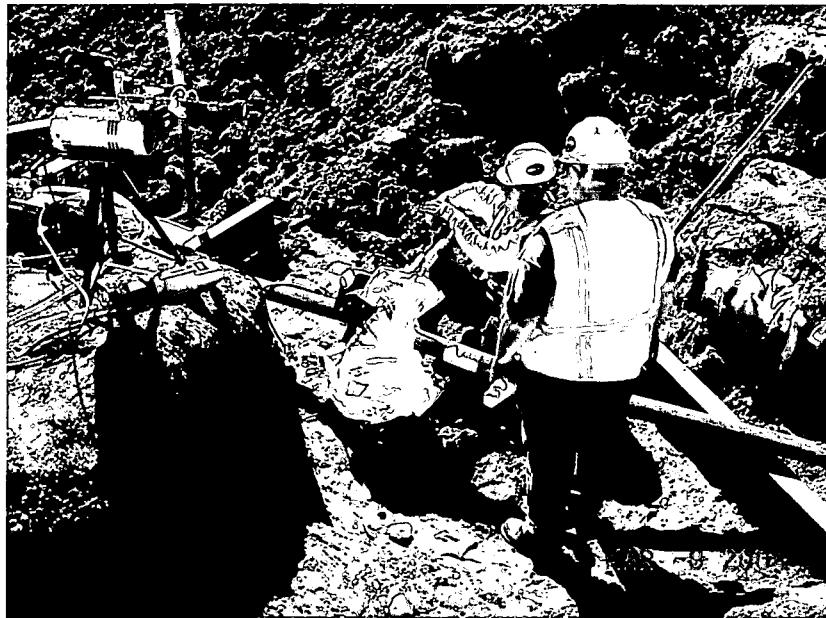
Cutting of a Building 779 OPWL

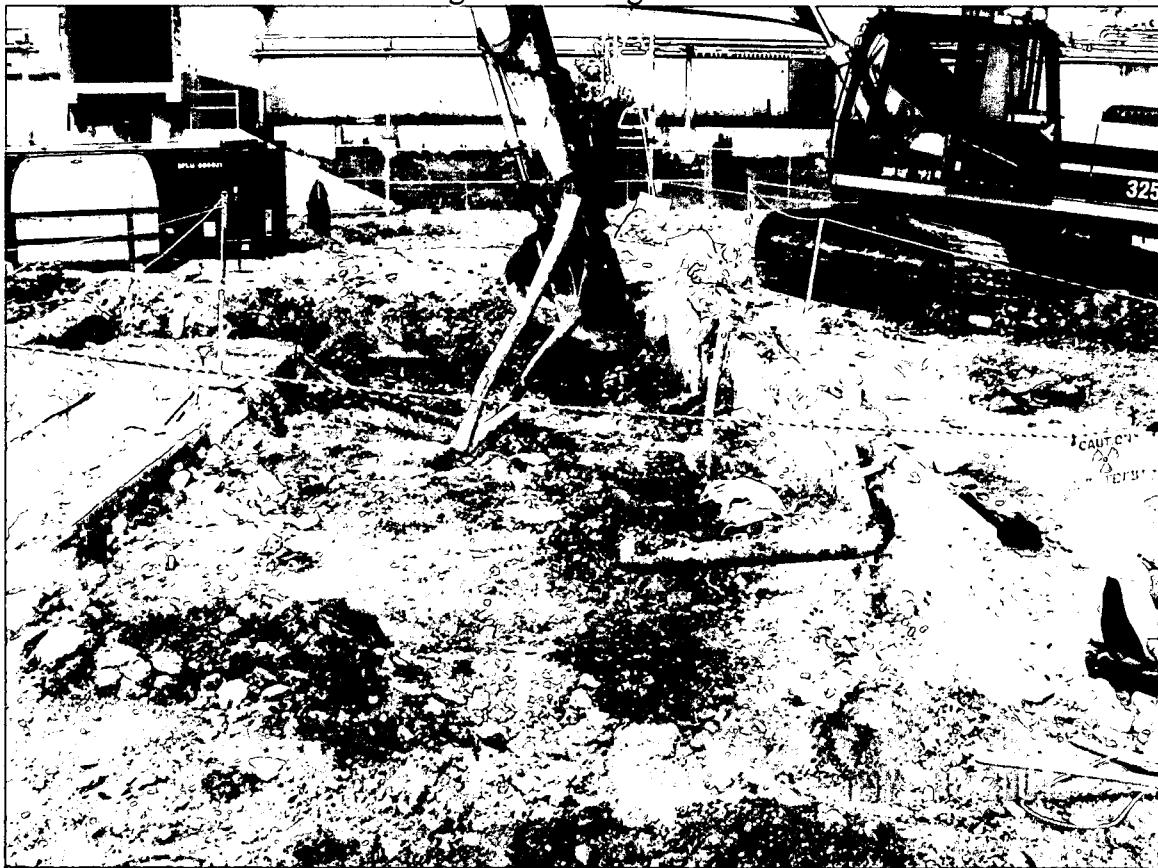
Building 779 North Side Footer Wall

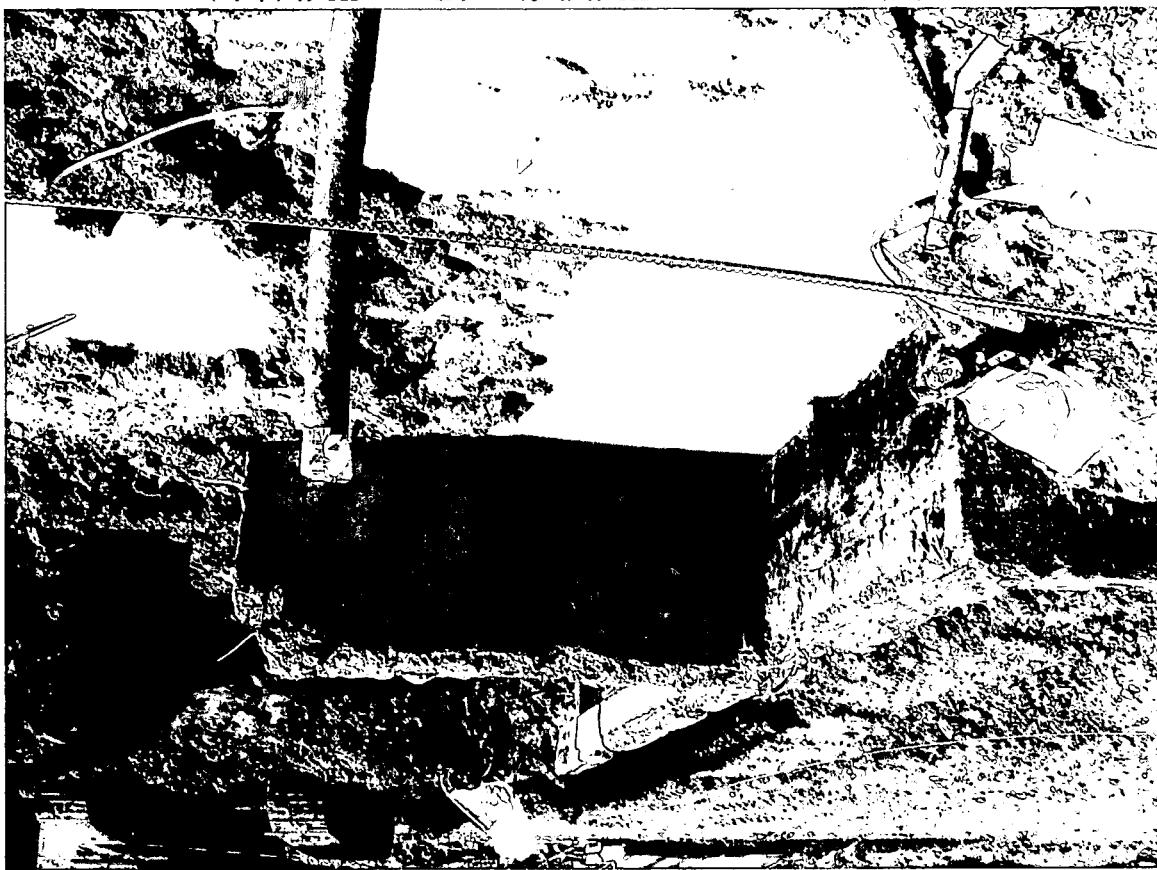
Building 779 Basement Wall (left) and Footer Wall (right)

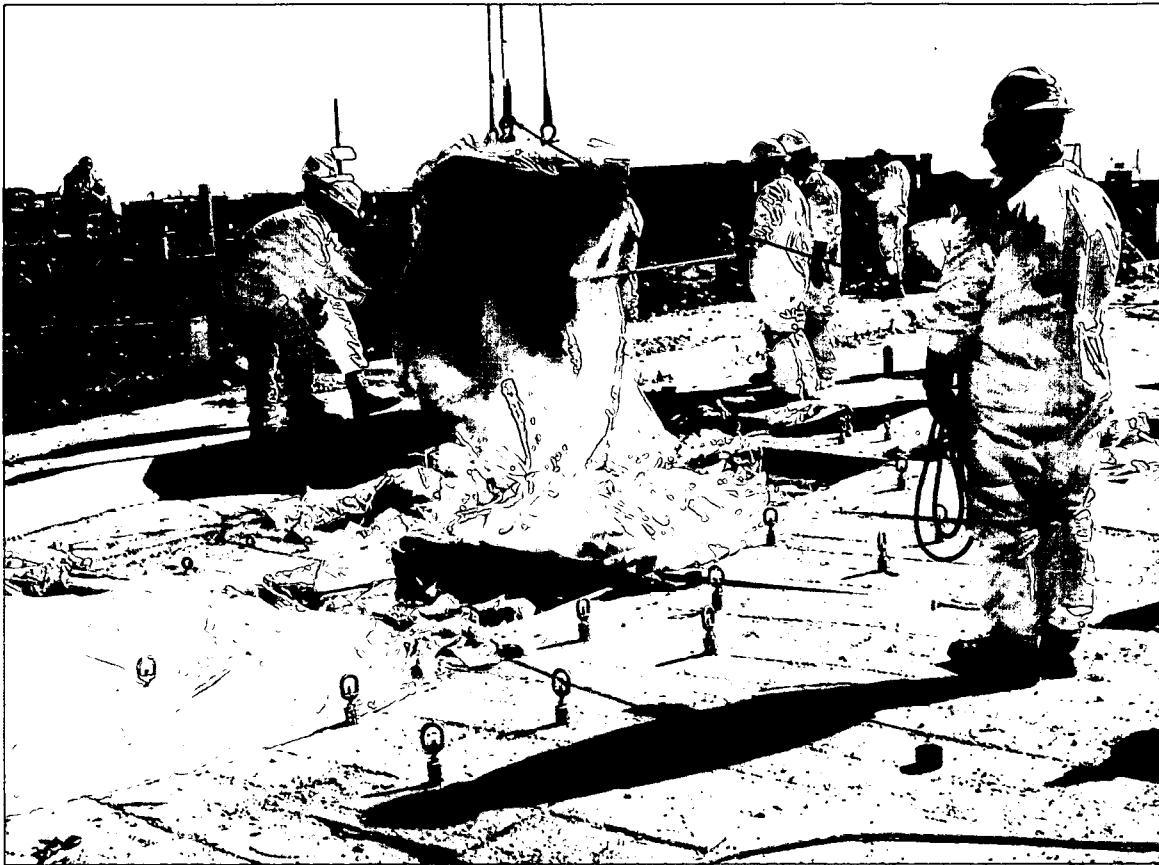
Lifting of a 4'X 4' Section of the Building 779 Contamination Area Slab

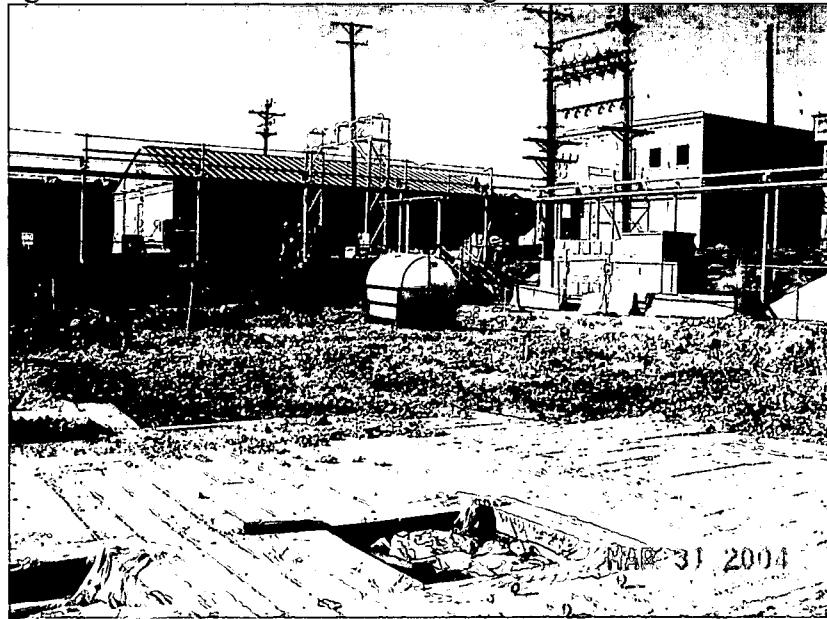
Building 779 Contamination Area, With Sections Removed and Remaining, and Sampling Locations

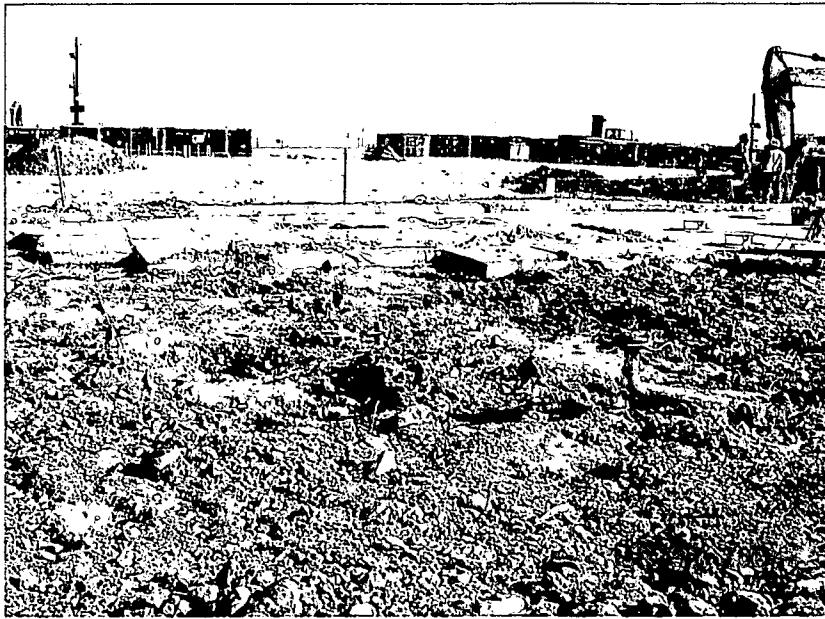
Building 779 Contamination Area, With Sections Removed and Remaining, and Sampling Locations

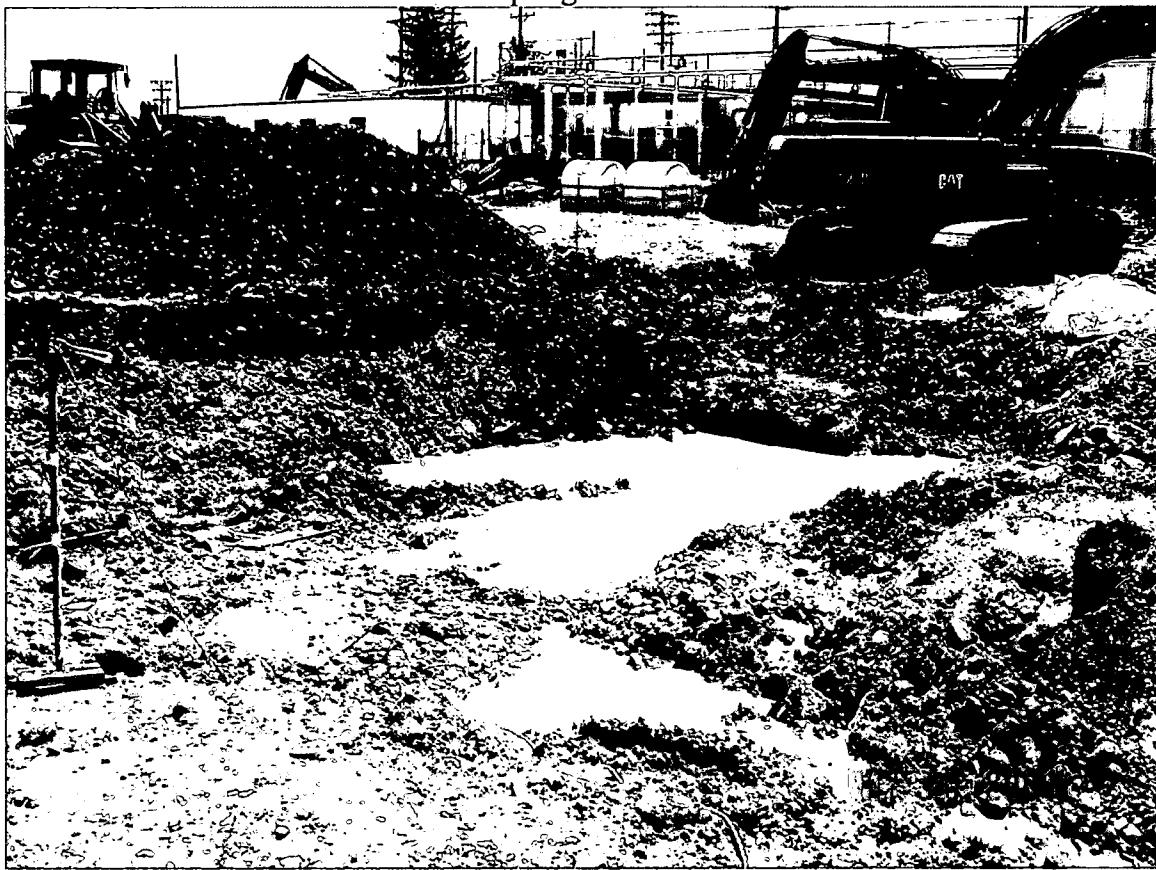
Building 779 Contamination Area Final Configuration Prior to Backfilling

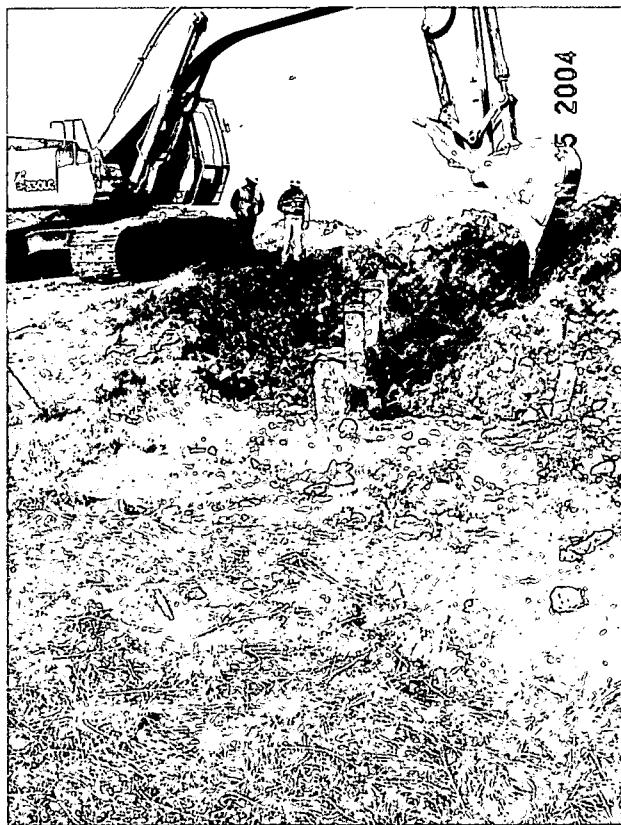
Vertical Cooling Tower Lines by Building 786

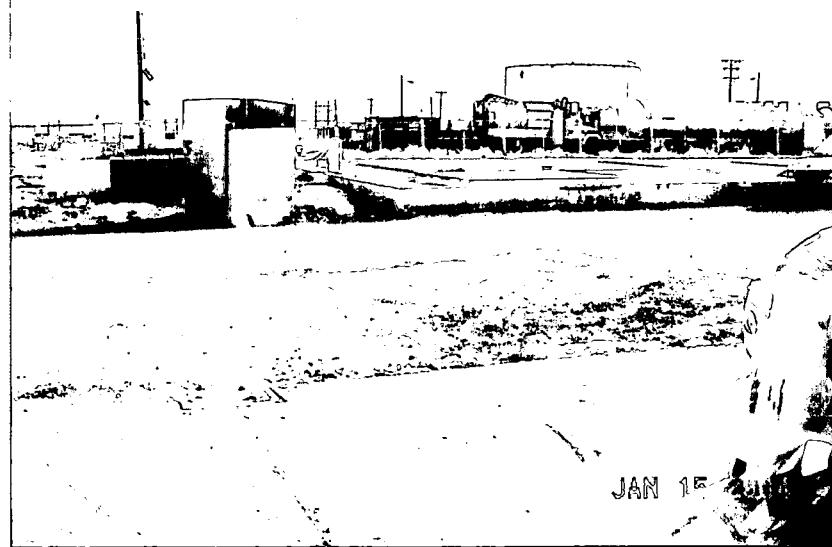
Building 782 Slab

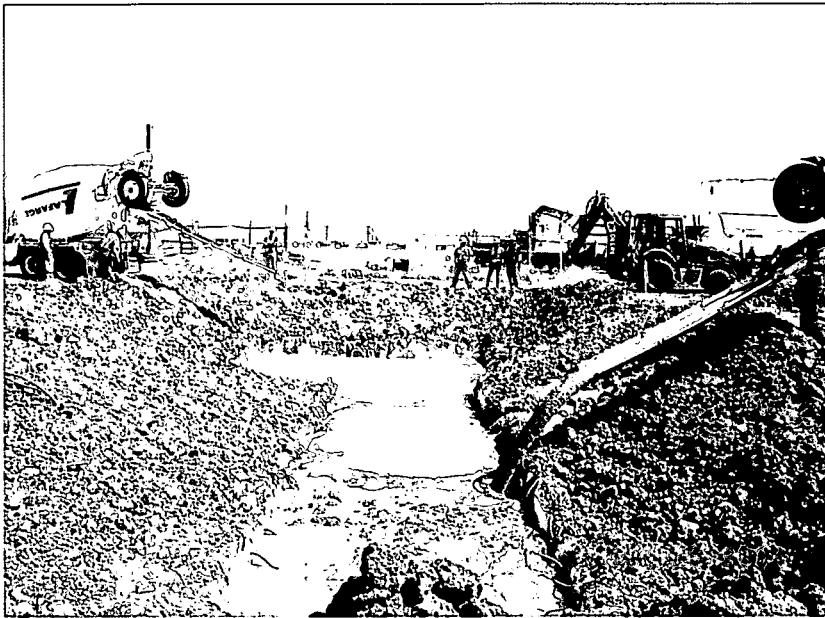
Delivery of Flowable Fill Concrete into the Building 782 Tunnel

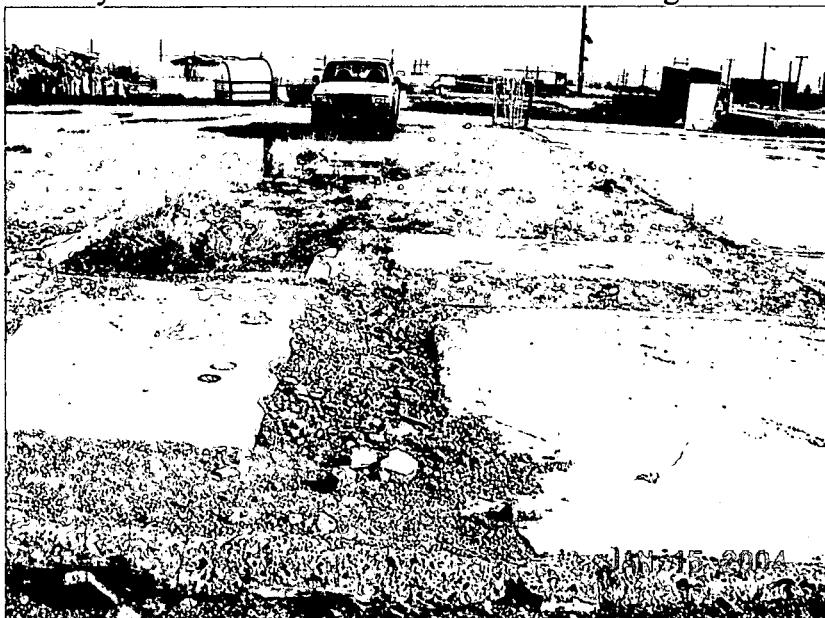
Building 779 Transformer Pads

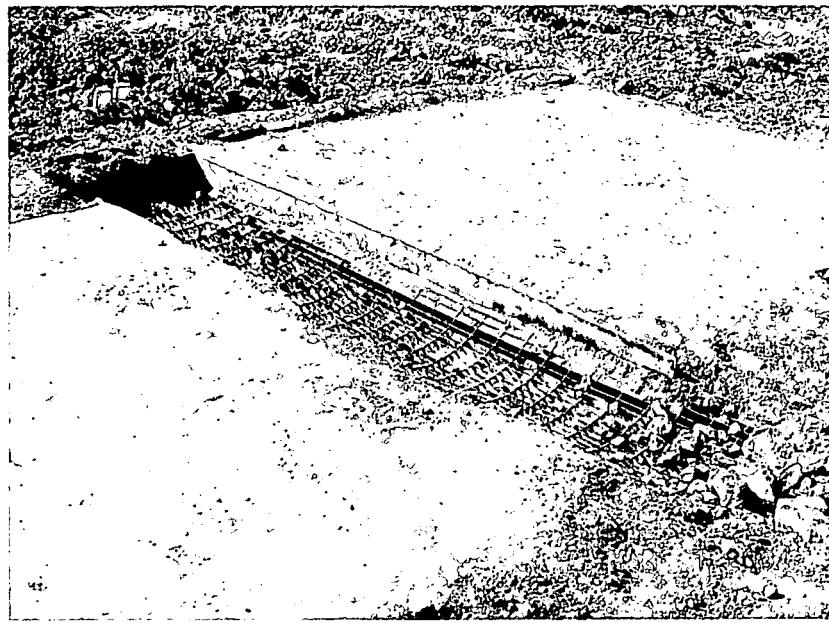
Building 779 PCB Transformer Pads and Trough

Prior to 1987, dielectric fluid containing polychlorinated biphenyls (PCBs) leaked from Transformers 779-1 and 779-2, formerly located on the northeastern side of Building 779 adjacent to the southern side of the 779 loading dock. A surface soil sample from Sampling Location SS481194 indicated the presence of PCBs at 21,000 micrograms per kilogram ( $\mu\text{g}/\text{kg}$ ). Pre-accelerated action surface soil samples were also collected at six locations around the transformer pads for PCB and isotopic analyses. Aroclor-1260 was detected in all six samples, from 15,000 to 680,000  $\mu\text{g}/\text{kg}$ . Pu-239/240 was detected in all samples; the highest activity was 115 pCi/g. Analytical results are shown on Figure 3.

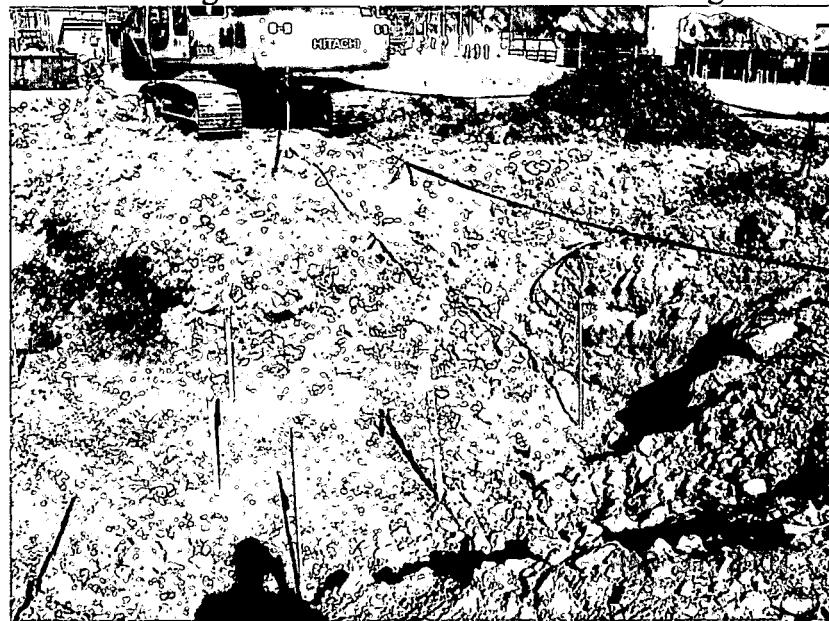
Excavation of PCB-Contaminated Soil Beneath the Building 779 Transformer Pads

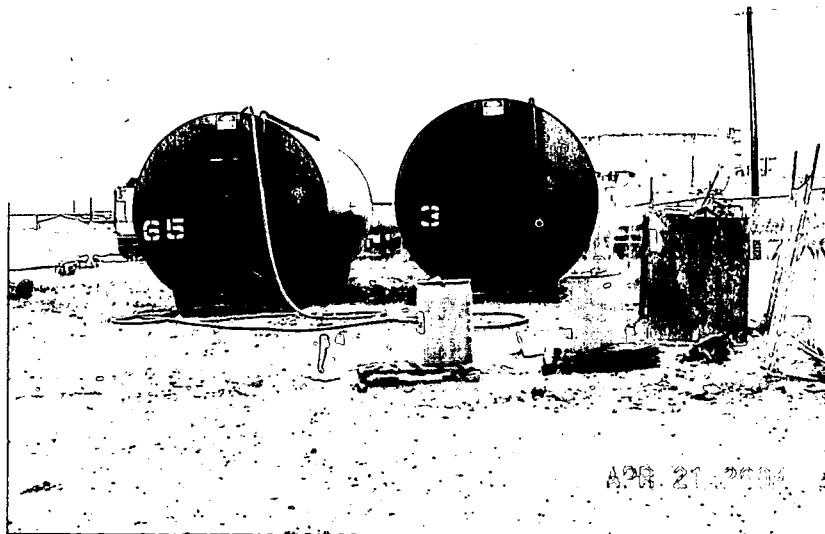
Project Wastewater Collection Tanks

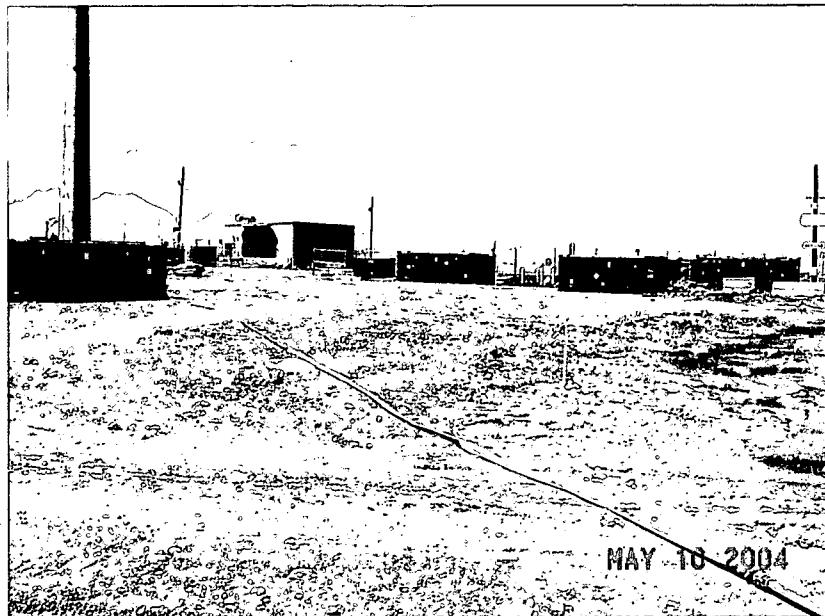
Project Site After Slab Removal

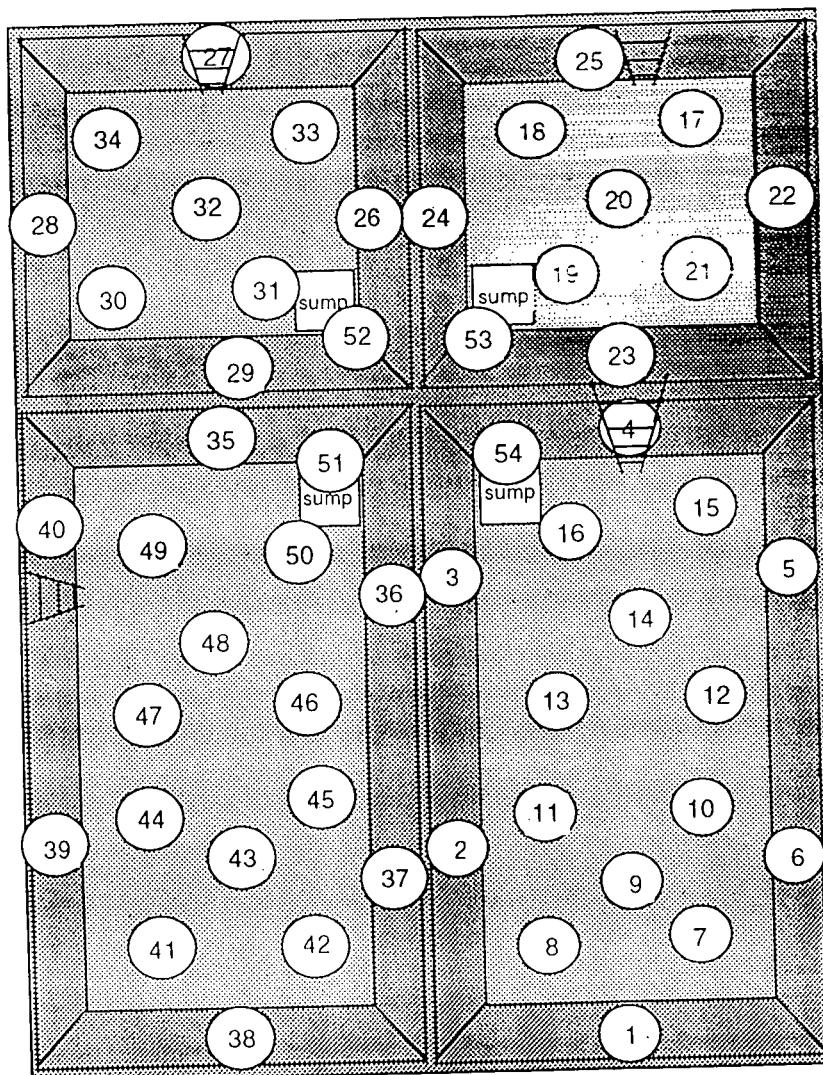
Drawing Showing Survey Points

Survey picture is of the pits in  
the 779 basement looking  
down from above.

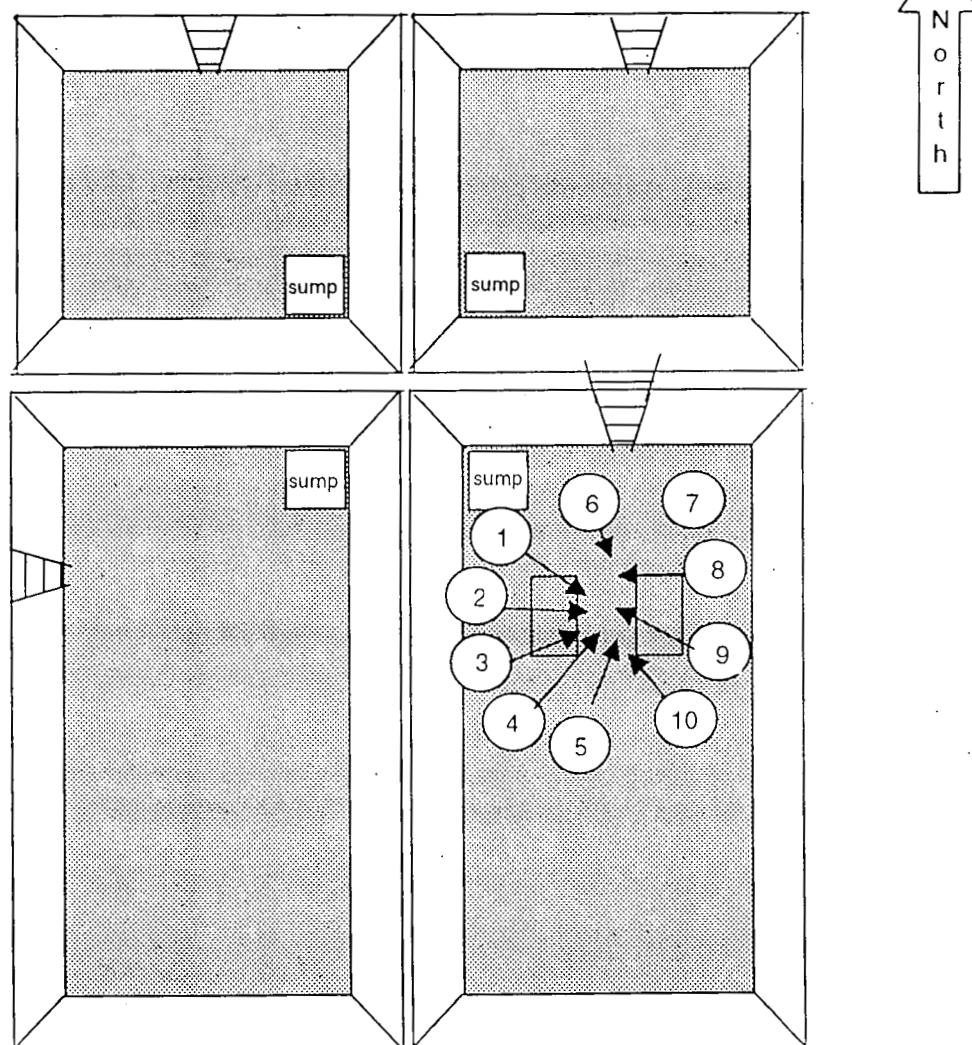
### Drawing Showing Survey Points

Survey picture is of the pits in  
the 779 basement looking  
down from above.

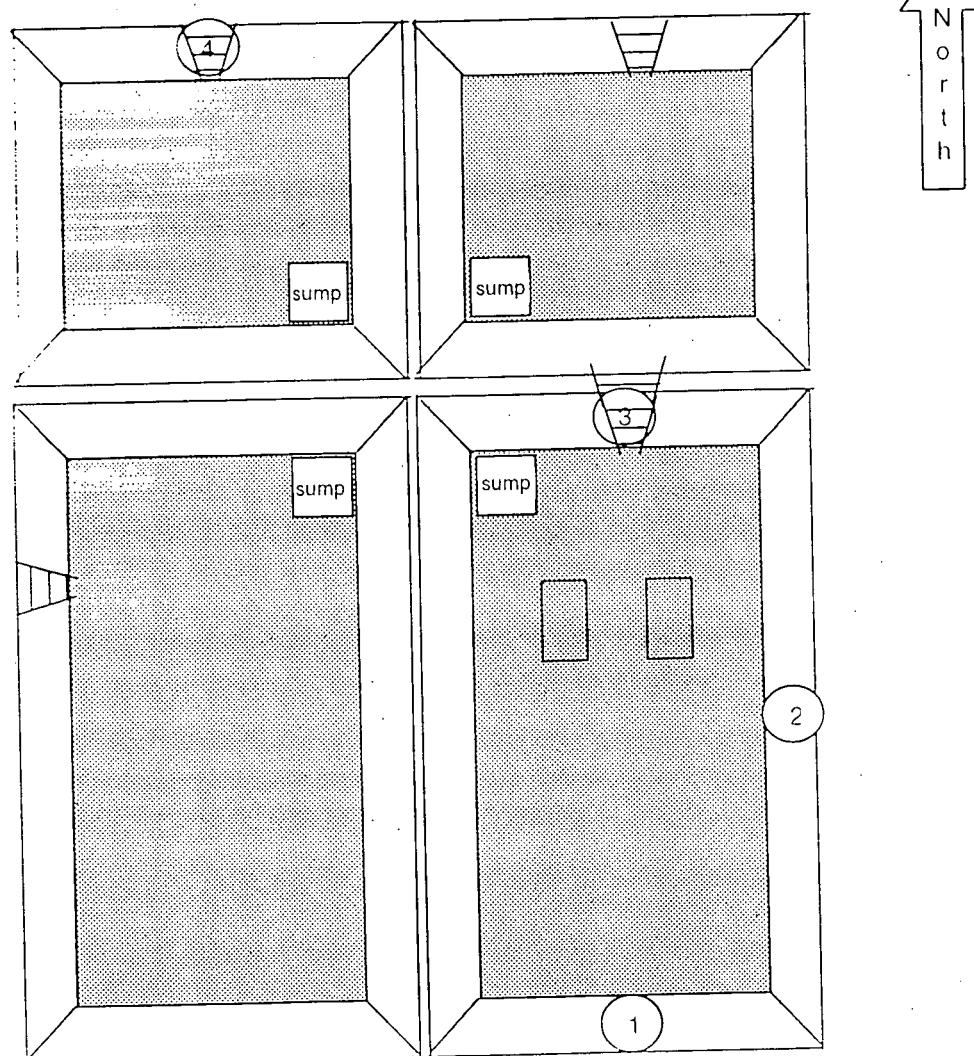
### Drawing Showing Survey Points

Survey picture is of the pits in  
the 779 basement looking  
down from above.
